INVENTORY FORM FOR STATE HISTORIC SITES SURVEY

Yates-Tolson Building

104-106 North Commerce Street

Centreville

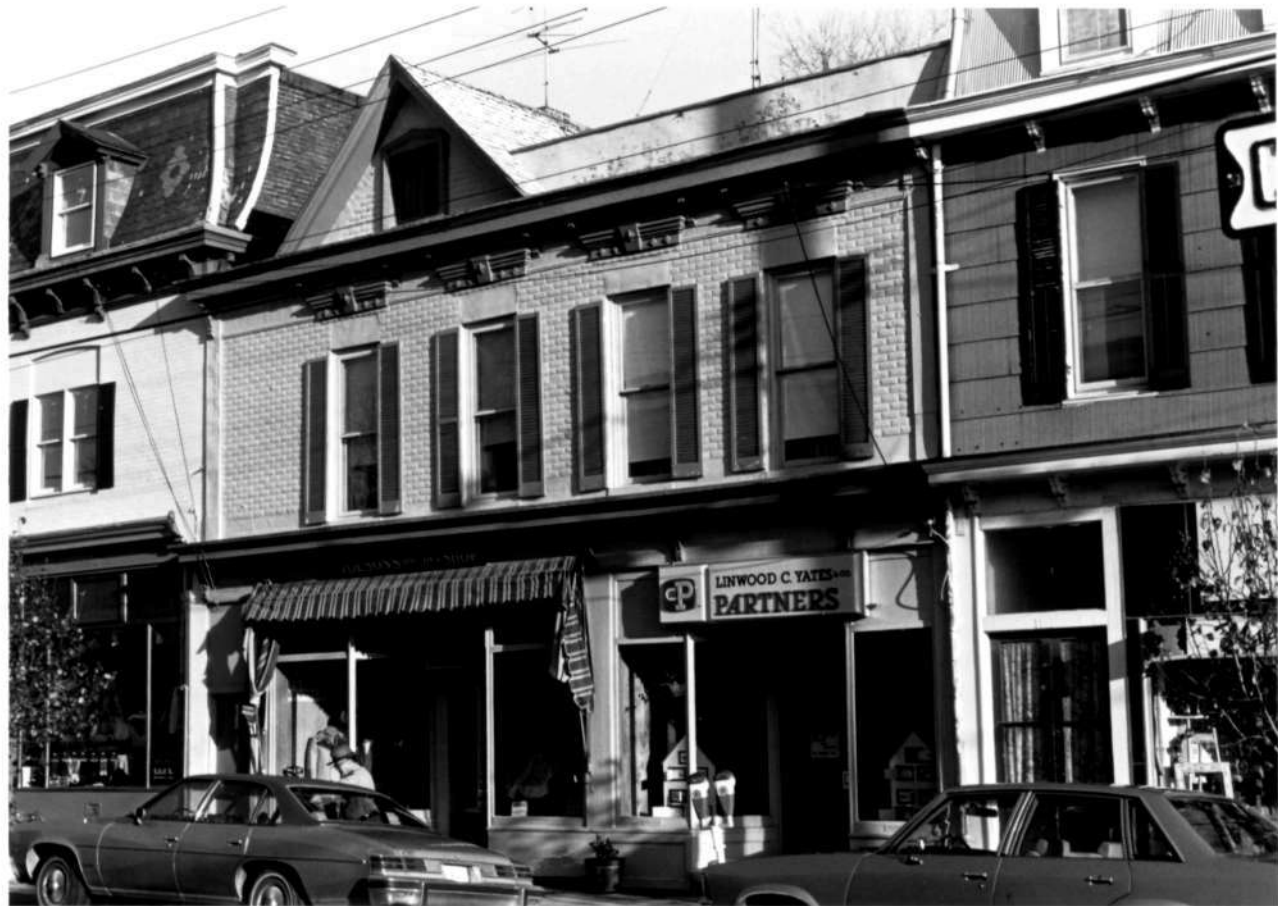
QA-322
104-106 North Commerce St.
Centreville, Maryland
Orlando Ridout V 1980
View from Southwest

The first story of the street facade consists of two similar store fronts, each with recessed central entrance doors flanked by large shop windows. A smaller door at the north end of the facade opens into a narrow alley between the north wall of 106 and the south wall of the adjacent Harmon Building. A bracketed cornice crosses the facade between the first and second story. Four 1/1 windows with louvered shutters are ranged across the second story. A second bracketed cornice crosses

the facade above the second story. Both cornices have complex crown molds, a deep soffit, and simple, scrolled brackets. The facade of the building is covered with pressed tin stamped with a brick pattern; decorative metal hoods add a pleasing detail above each window opening. The pitched gable of the original building projects above the second story cornice of 106. A paired Victorian window with multiple colored panes is centered in the gable. The eaves of this gable are boxed and trimmed in the same manner as the cornice. To the right of the gable, a parapet wall forms the top of the addition that comprises 104.
